1234 Main St.  
San Diego CA 92114

Prepared for:  
Client Name

Viewpoint Property Inspections  
viewpointpisd@yahoo.com

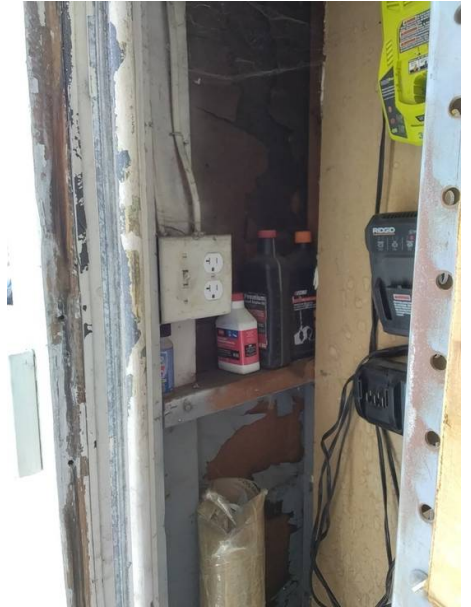
I observed a receptacle in the attached garage without GFCI (or ground fault circuit interrupter) protection. GFCI protection is required for all 15- and 20-amp receptacles, including outlets for refrigerators, garage door openers, and washing machines.

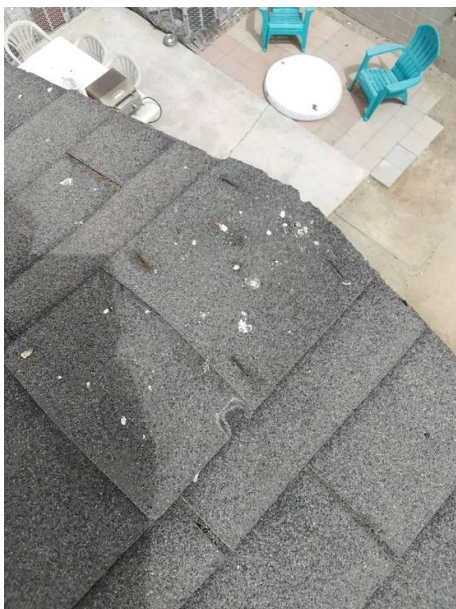
I observed indications of exposed fasteners at the roof-covering materials. Fasteners should not be exposed. Potential water entry points. Roof could leak. Further evaluation and correction is recommended.

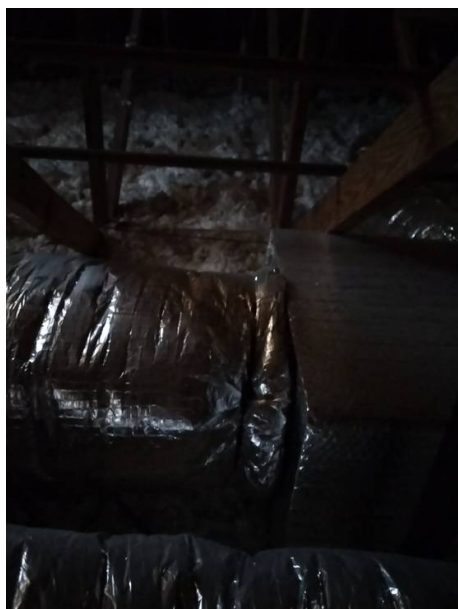
I observed indications that the access to the attic was not insulated and sealed properly. This condition will create a heat/energy loss area. Adding insulation and air sealing at the attic access is recommended.

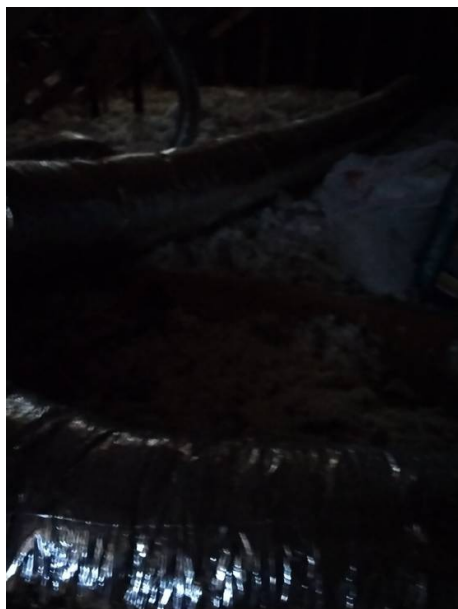
I recommend air sealing and adding insulation to the areas that need more insulation.

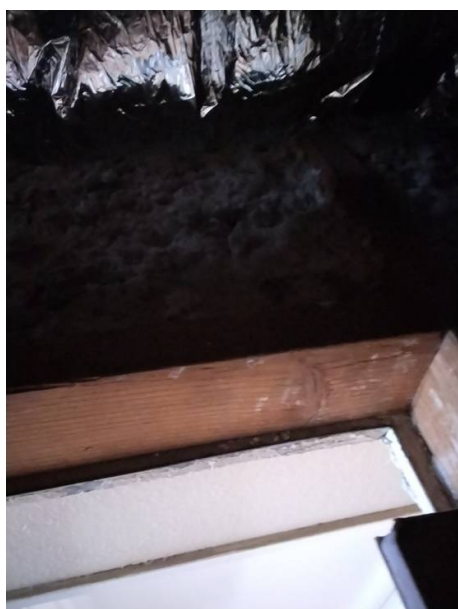
I observed indications of the general absence of insulation in the unfinished attic area.

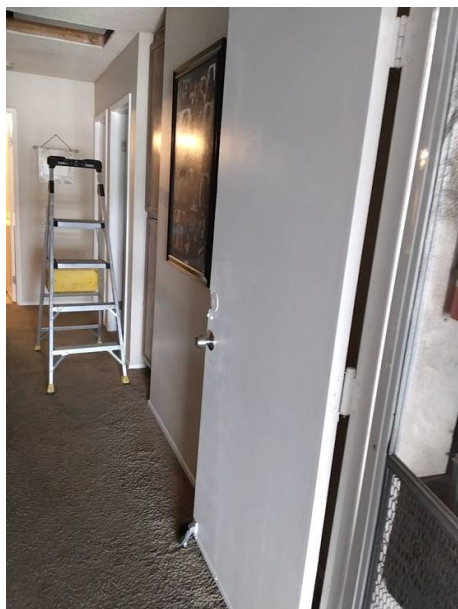
The door should be a solid wood door at least 1-3/8 inches thick, a solid or honeycomb-core steel door at least 1-3/8 inches thick, or a 20-minute fire-rated door.

The door should be equipped with a self-closing or an automatic-closing device.

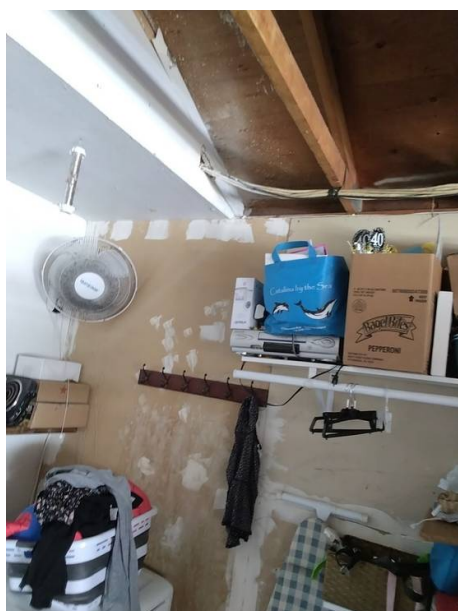
Garage wall had damaged drywall. Recommend drywall contractor repair.

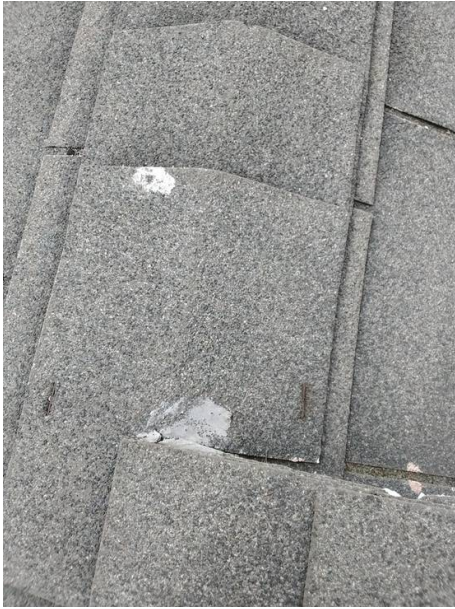
I observed improper fastening at the roof-covering materials. Prone to leaking. Correction and further evaluation is recommended.

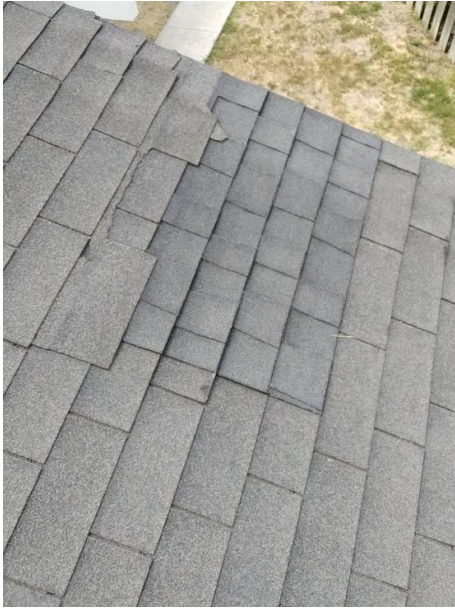
I observed during my inspection that the system appeared to be old and at the end of its service life. It may not be reliable. Ask the homeowner or occupant about its recent performance. Regular maintenance and monitoring of its condition is recommended. Budgeting for repairs and future replacement is recommended. [InterNACHI's Standard Estimate Life Expectancy Chart for Homes](#)

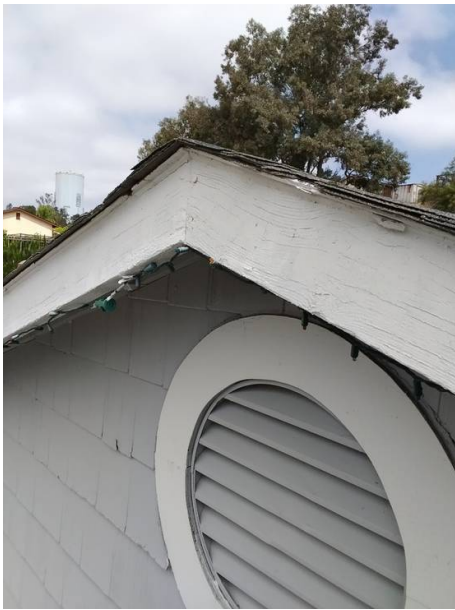
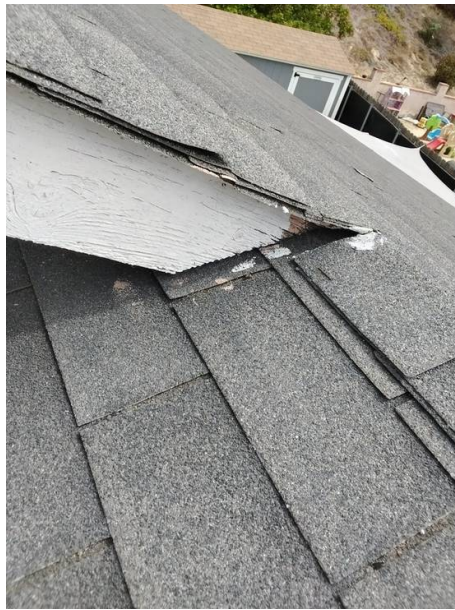
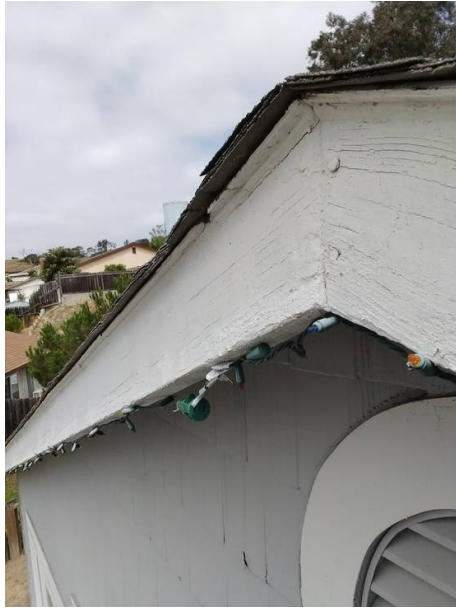
I observed areas where flashing was missing. Not installed. Improper installation of flashing. These areas of missing flashing are prone to water penetration. Flashing is installed to provide protection against roof leaks and to divert water away from certain areas. Correction and further evaluation is recommended.

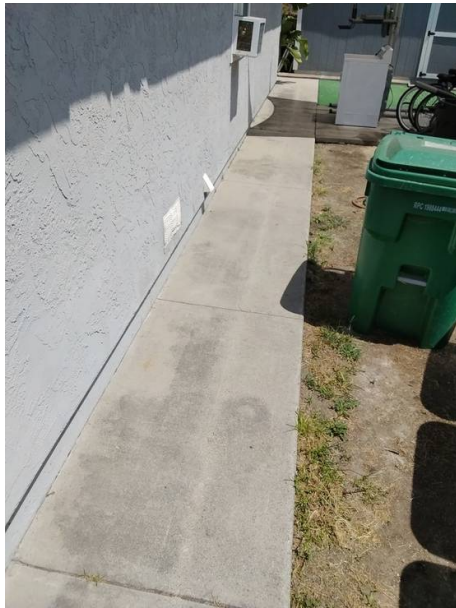
I observed minor cracking and no major damage at the walkway.  
Monitoring is recommended.

I observed a trip hazard. This condition is a safety concern.  
Correction and further evaluation is recommended.

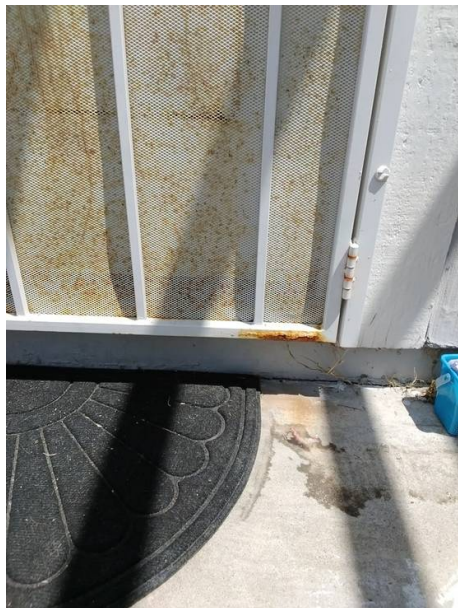
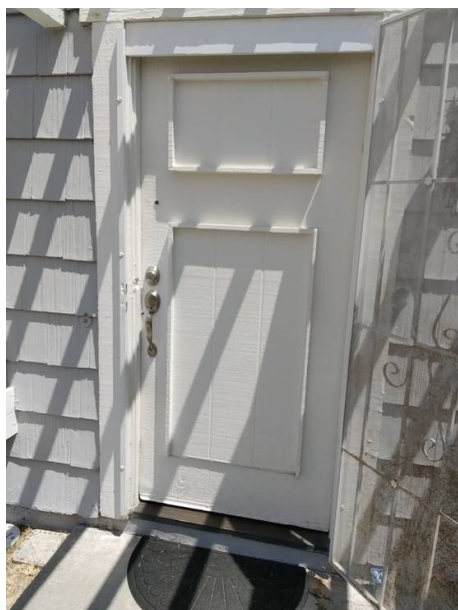
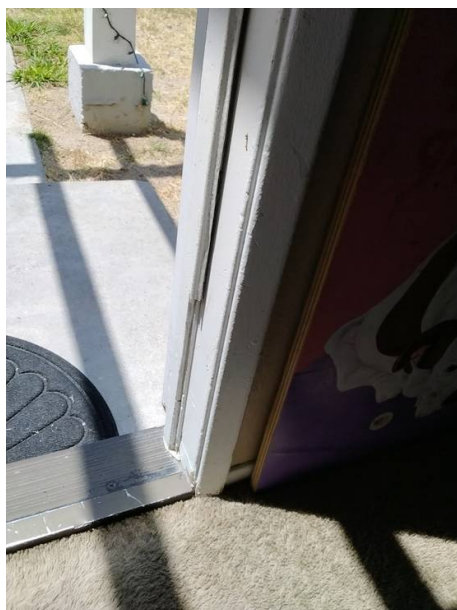
I observed wood rot at the exterior door.  
Correction and further evaluation is recommended.

I observed a defect at the screen door.  
Correction and further evaluation is recommended.

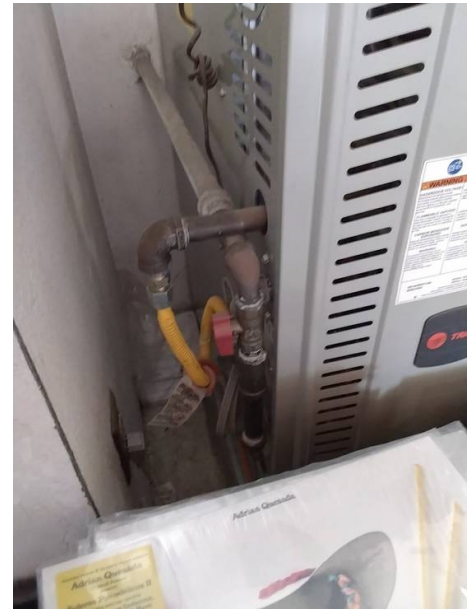
The heating system was inaccessible. The inspection was restricted and limited. Correction and further evaluation is recommended.

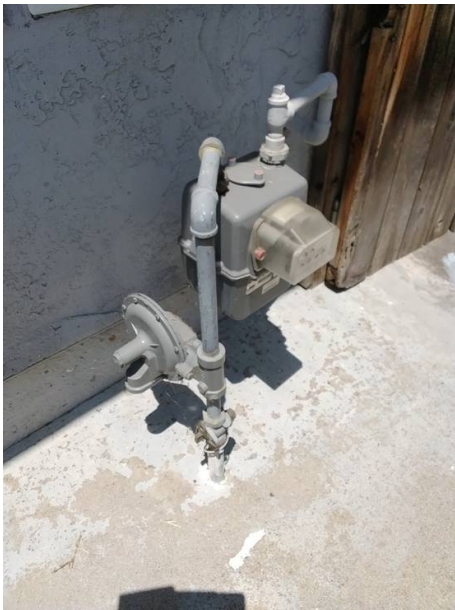
I observed some minor surface rust at the gas meter components. Monitoring recommended.

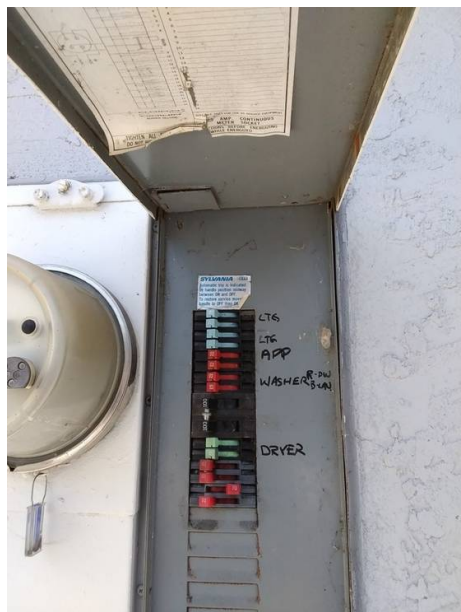
I observed a breaker in the "off" position prior to inspecting the electrical panel. Recommend asking the homeowner what this breaker is connected to, and why it is off.

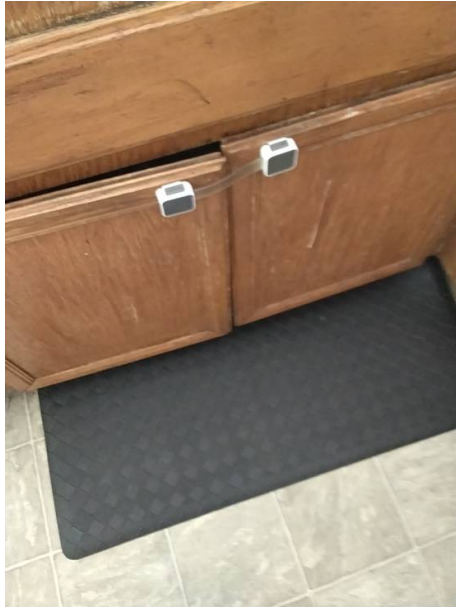
I observed a loose cabinet door.

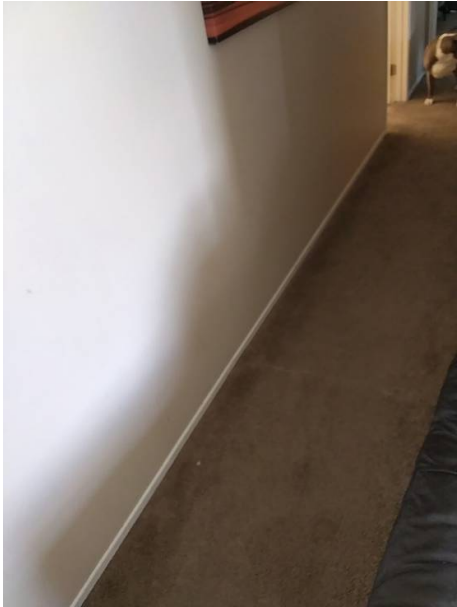
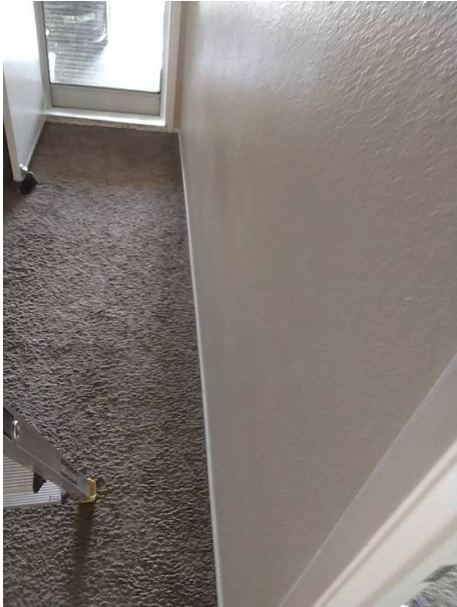
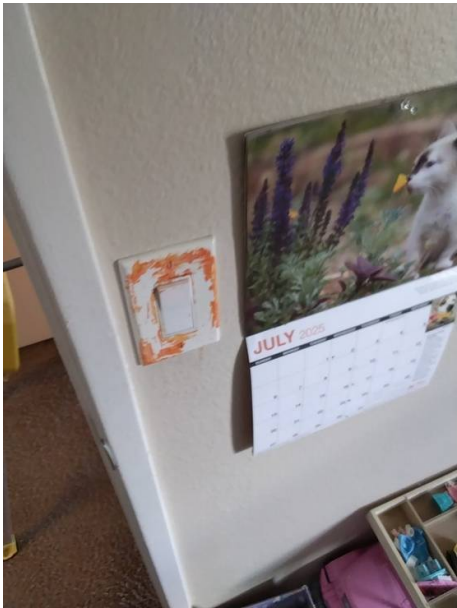
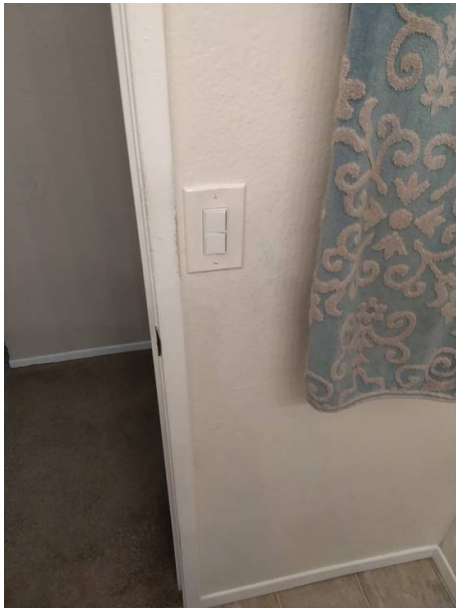
I observed a lack of wall receptacles.  
A receptacle should be no more than 6 feet apart along the wall.

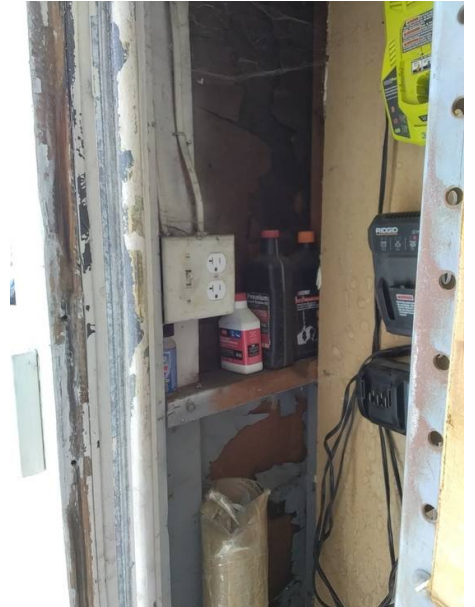
I observed a receptacle in the attached garage without GFCI (or ground fault circuit interrupter) protection. GFCI protection is required for all 15- and 20-amp receptacles, including outlets for refrigerators, garage door openers, and washing machines.

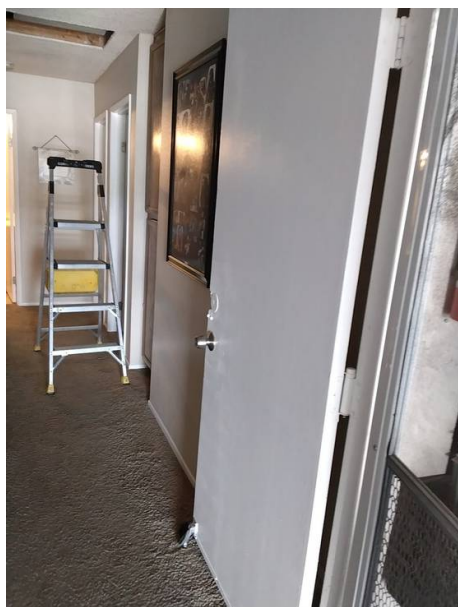
I inspected the door between the attached garage and the house.  
The door should be a solid wood door at least 1-3/8 inches thick, a solid or honeycomb-core steel door at least 1-3/8 inches thick, or a 20-minute fire-rated door.

The door should be equipped with a self-closing or an automatic-closing device.

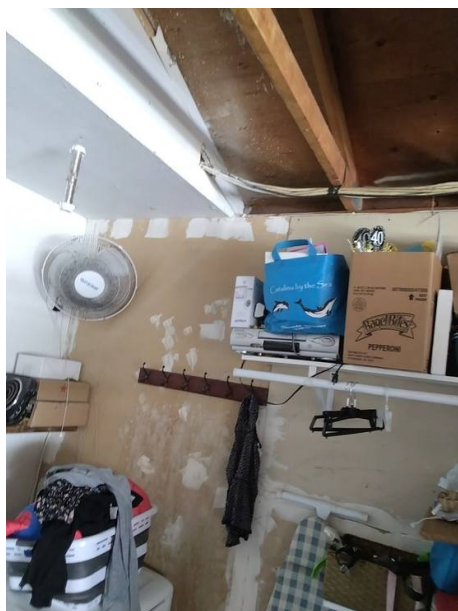
Garage wall had damaged drywall. Recommend drywall contractor repair.

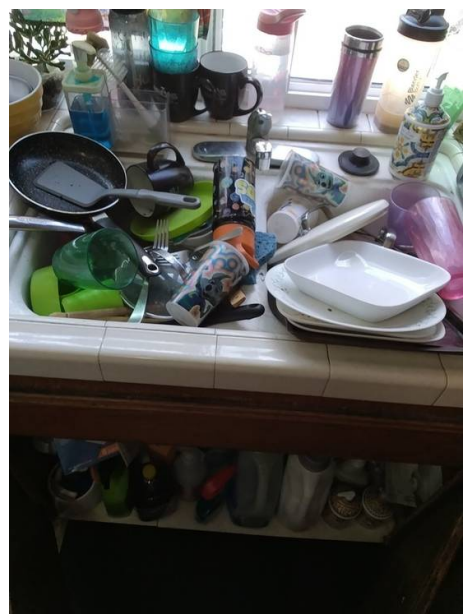
I observed indications of a defect at the kitchen sink.

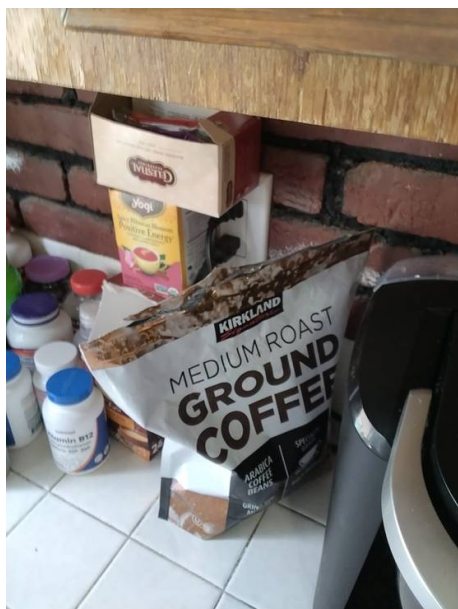
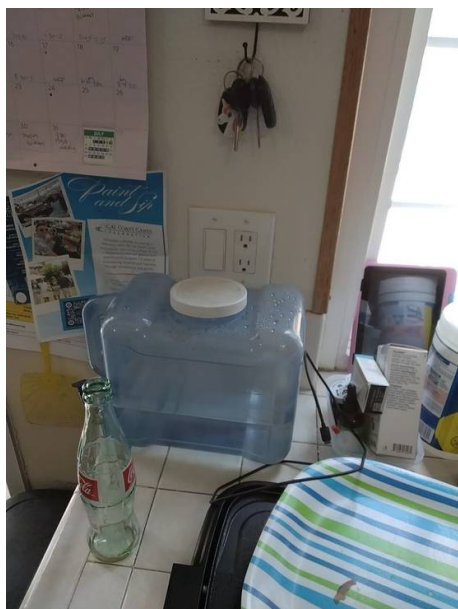
I observed indications of missing GFCI protection in the kitchen. All kitchen counter receptacles are required to be GFCI protected.

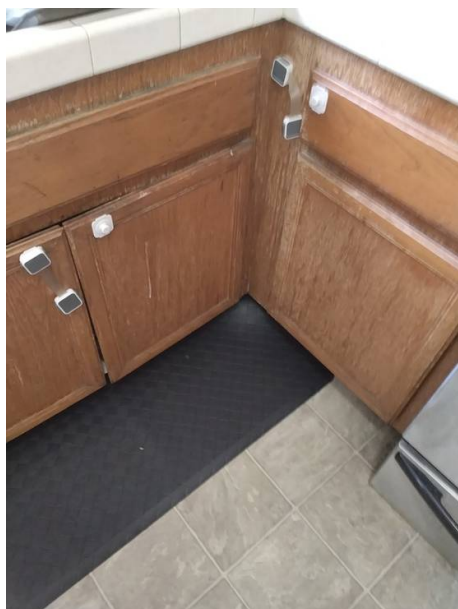
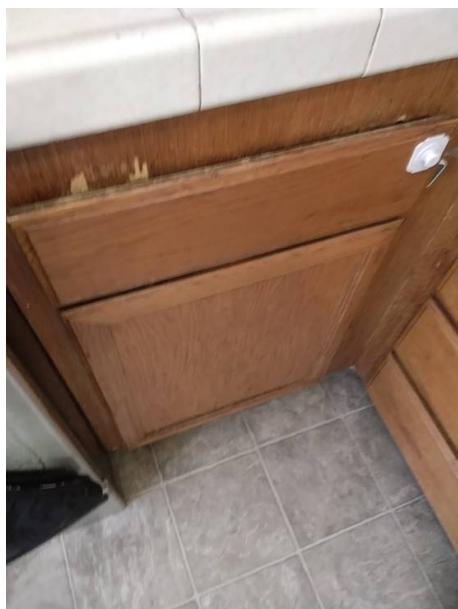
I observed worn areas and some damage at the cabinets.

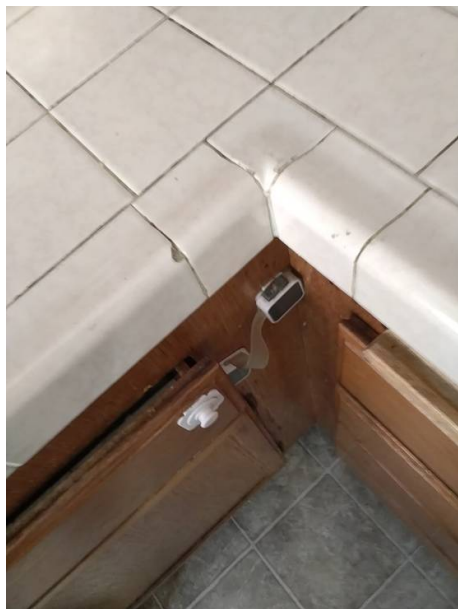
I observed worn areas and some damage at the countertops.

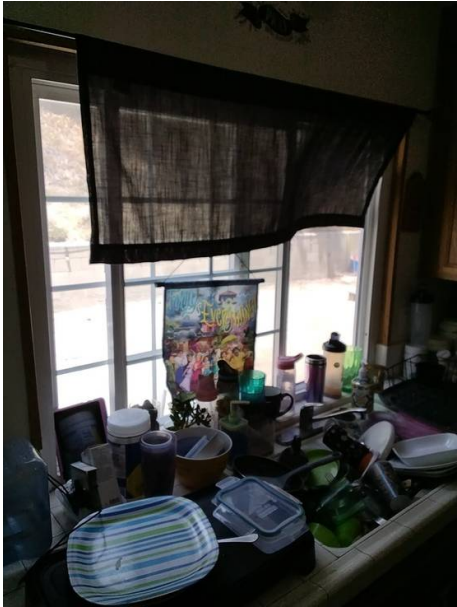
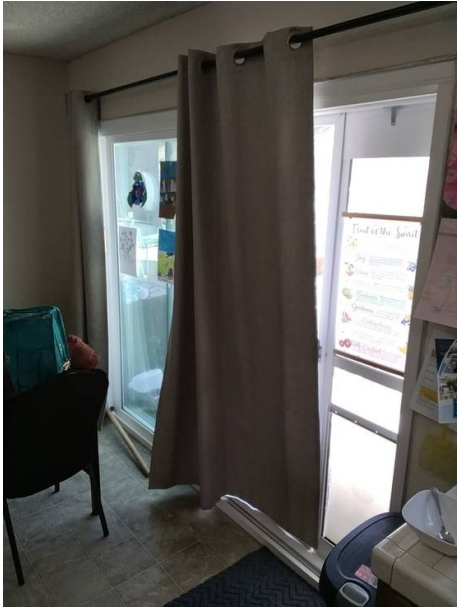
I observed a missing lock at a window.
